PHASE B REPORT

MATERIALS PROCESSING IN SPACE M512

CONTRACT NAS 8-28725

July 15, 1973

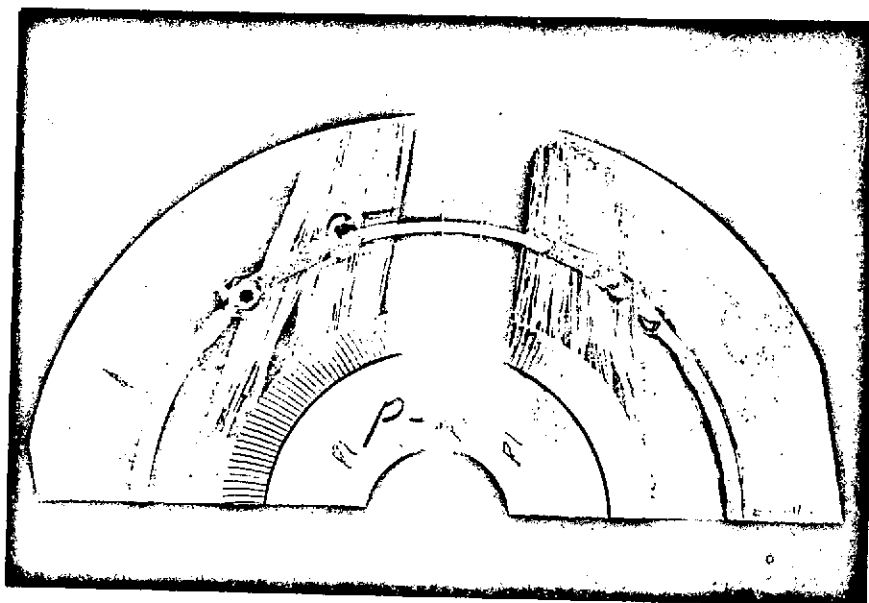
No defects were noted in the radiograph except crater cracks at the weld stops and dwells. Figure A-2 shows the appearance of this disc as received. The black area is a molybdenum spray coating used for a tracer. A section through the weld zone in the area of the tracer is shown in Figure A-3. No adverse effects of the tracer on the weld region were noted in this section.

FIGURE A-2. FRONT SURFACE OF P-1

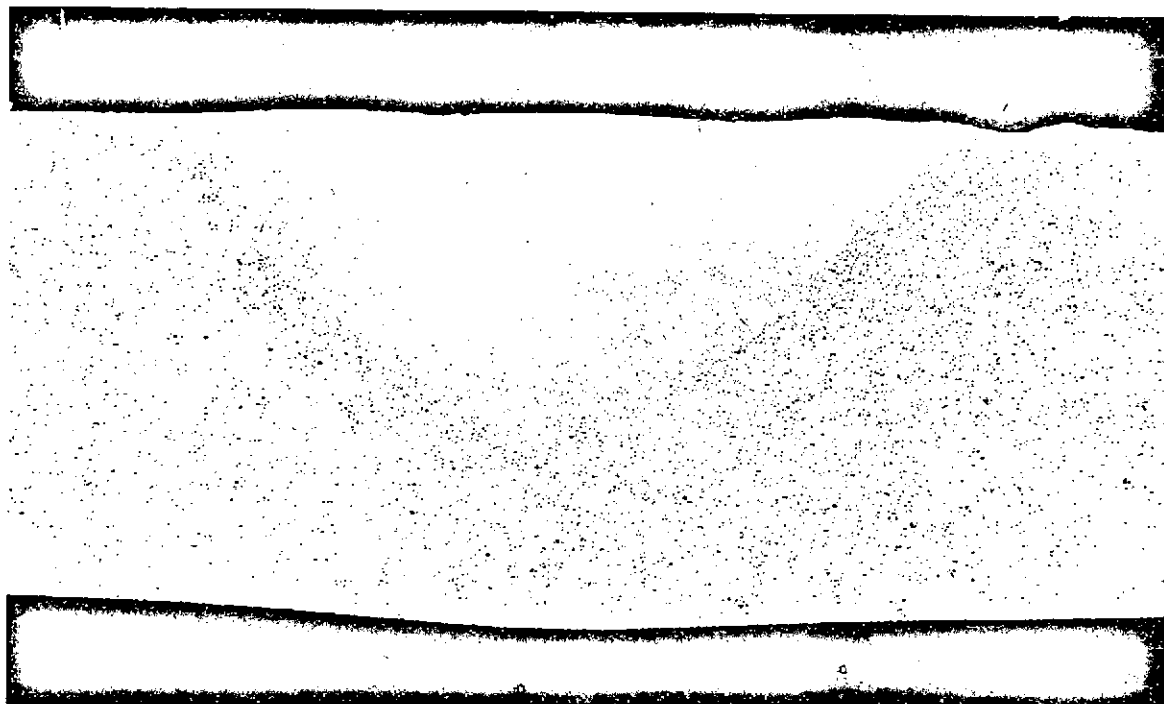
FIGURE A-3. SECTION P-1 AT TRACER REGION

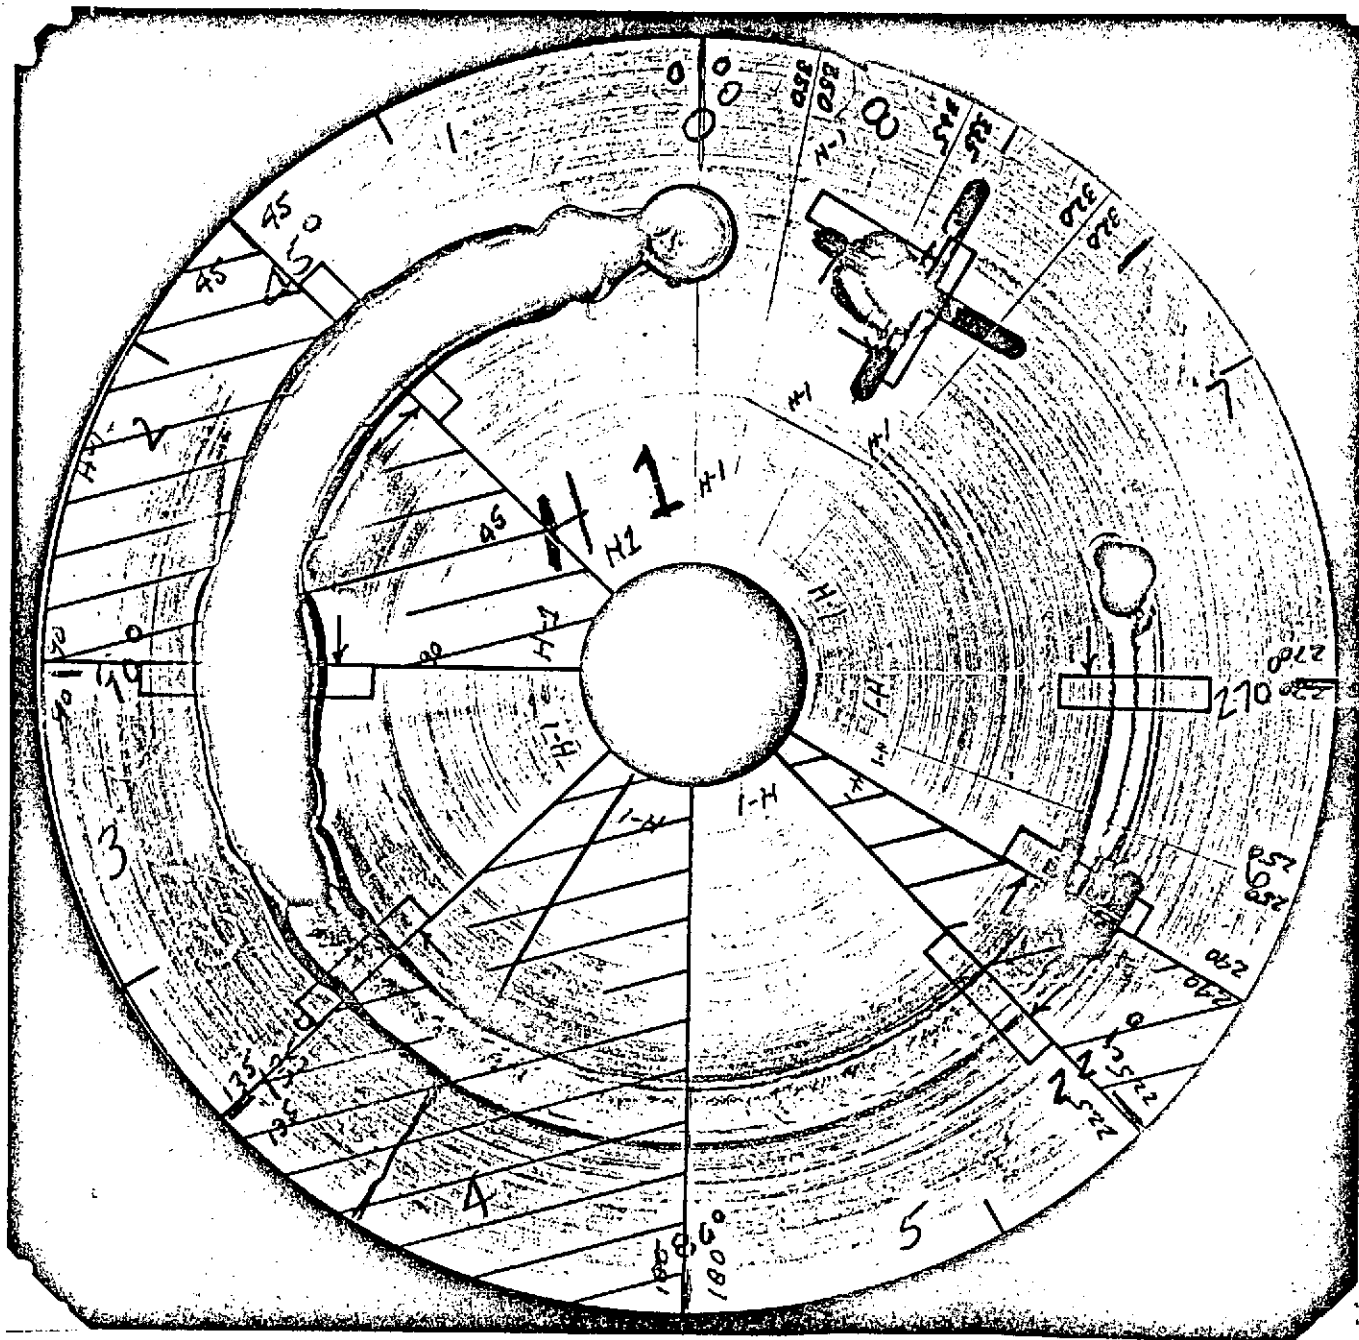
The radiograph showed longitudinal weld cracks near the weld start (125° to 135°), and near the molybdenum tracer (225° to 235°). Cracks in the dwell crater also were apparent. All of these cracks also were visible on the weld surface. Figure A-4 shows the front surface of Disc H-1.

FIGURE A-4. FRONT SURFACE H-1

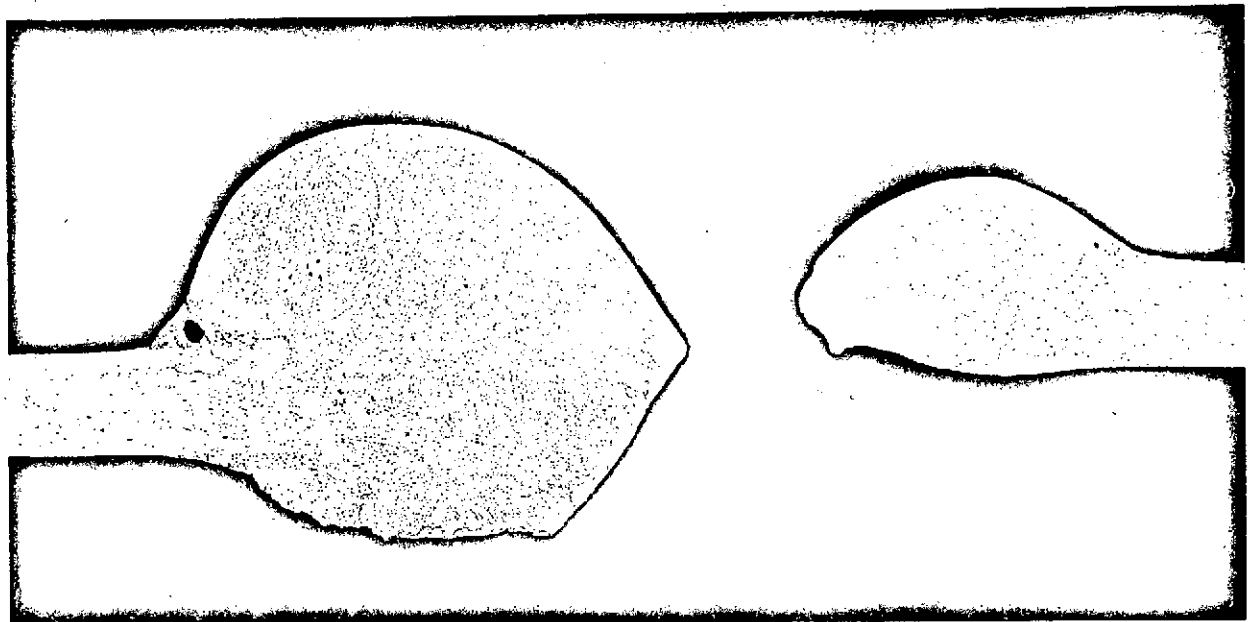
Figures A-5 through A-10 show the appearance and microstructural details in the cut region. Several areas on the cut surfaces indicate the presence of a contaminant or reaction zone. This has probably come from material vaporized from the surface under the weld disc. The very wide cut that resulted in this disc is indicative of an electron-beam power level favoring excessive penetration.

FIGURE A-5. SECTION THROUGH CUT REGION -H-1

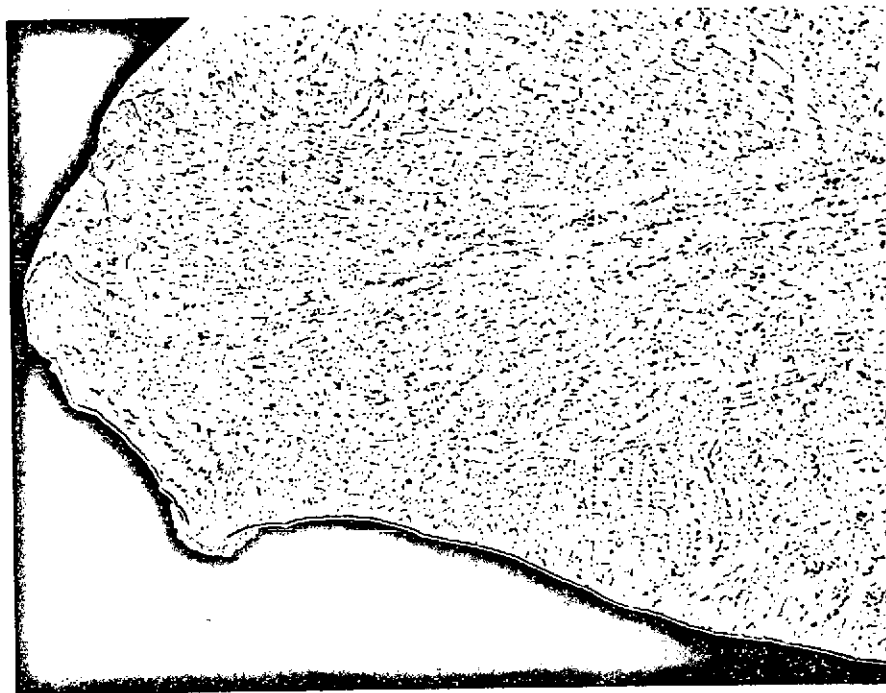
FIGURE A-6. SURFACE OF CUT ON INSIDE -H-1

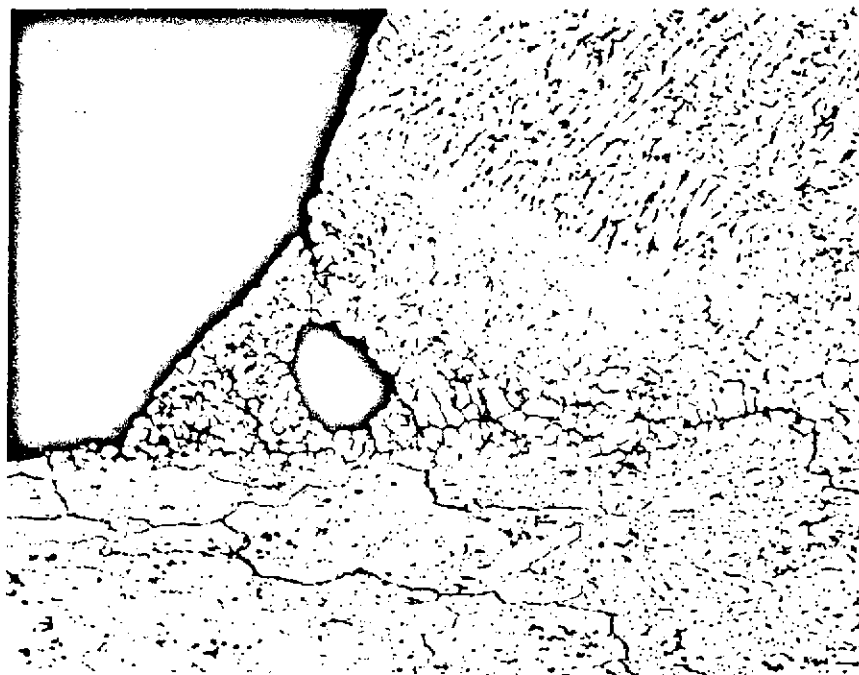
FIGURE A-8. PORE IN SECTION AT BASE METAL INTERFACE
H-1

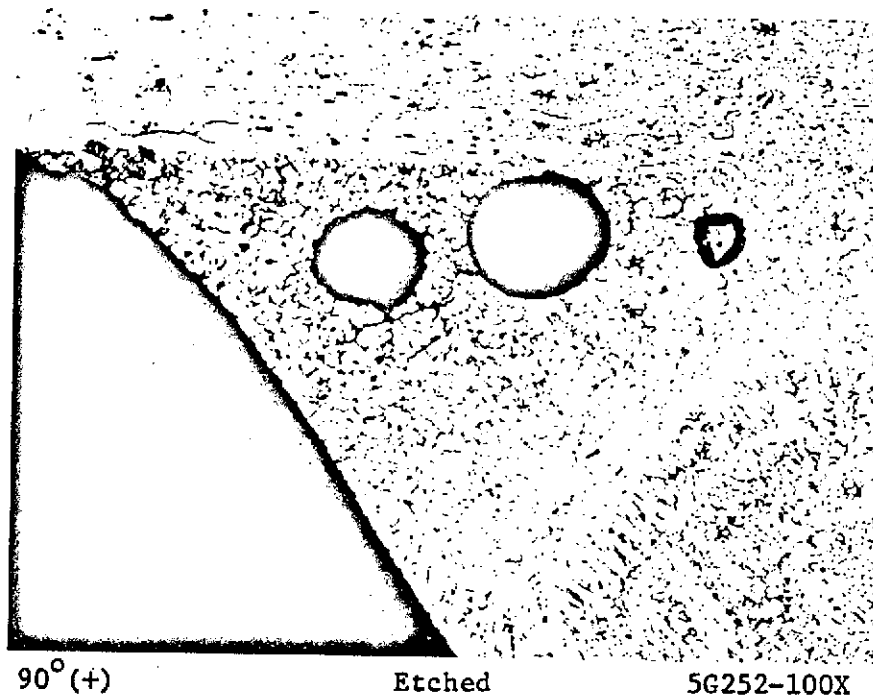
FIGURE A-10. PORES IN RAMP SECTION -H-1

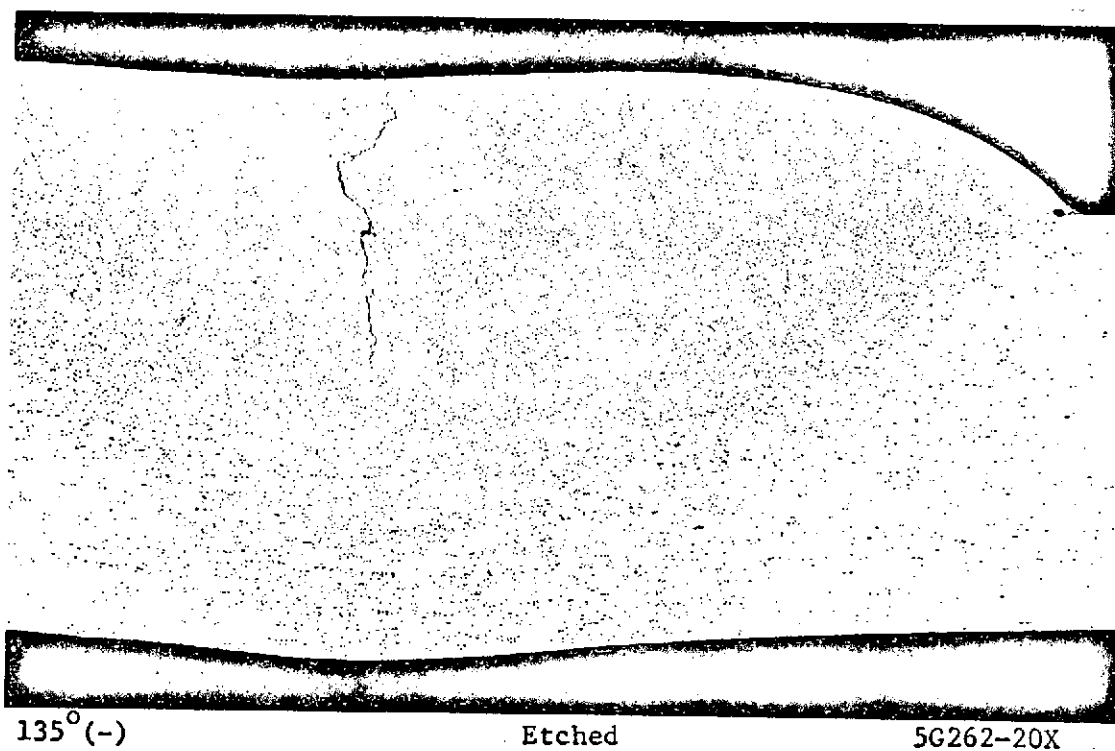
FIGURE A-11. SECTION THROUGH CRACK NEAR WELD START

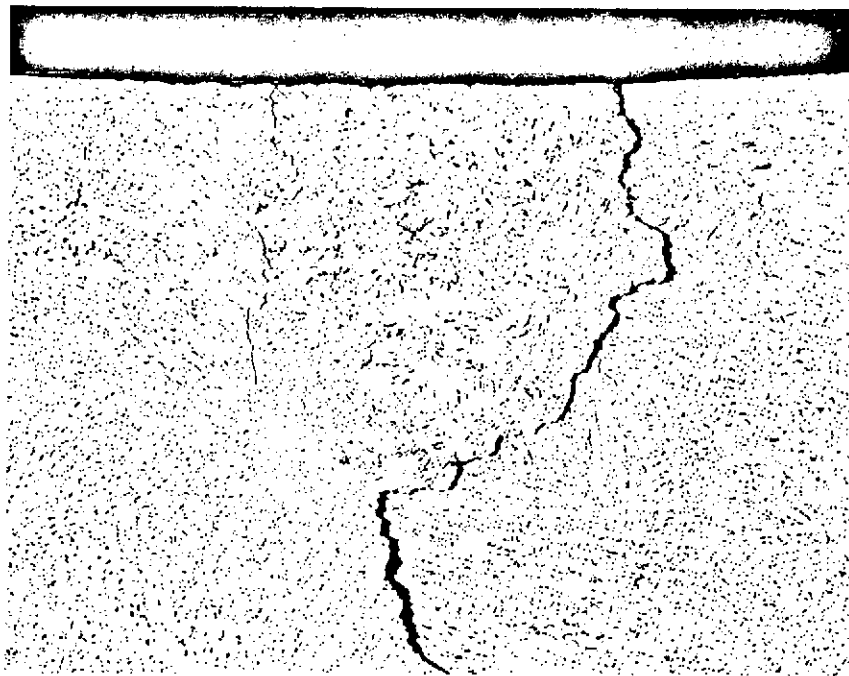
FIGURE A-12. ENLARGEMENT OF LONGITUDINAL CRACK
AT WELD START - H-1

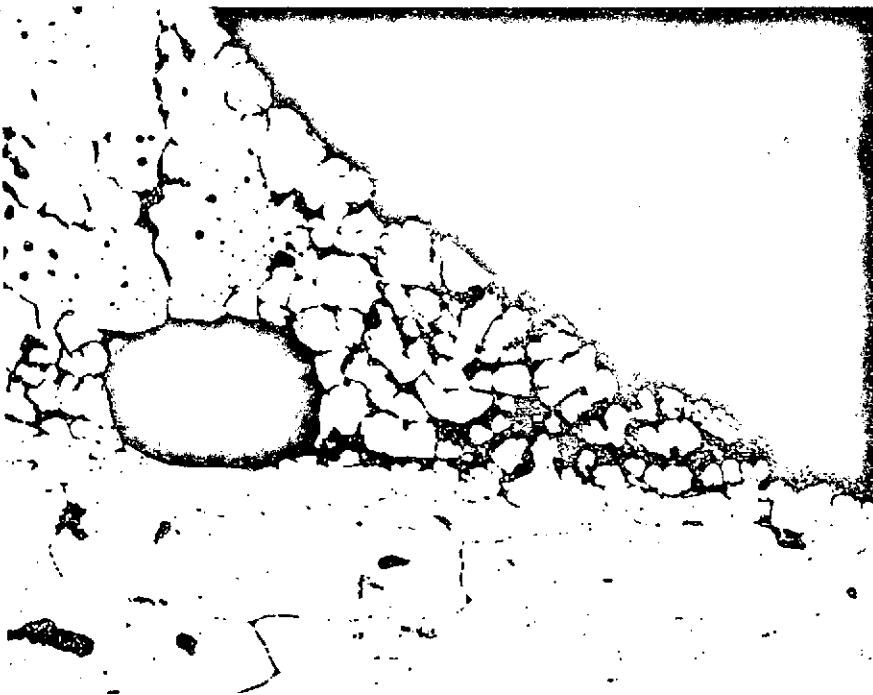
FIGURE A-13. PORE AT INSIDE EDGE OF WELD - H-1

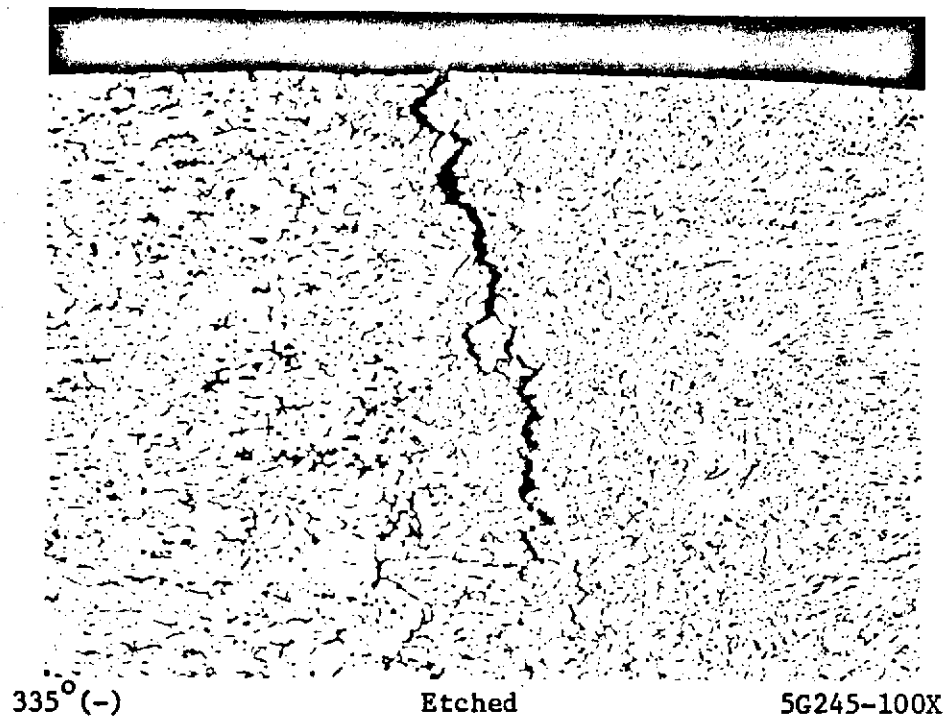
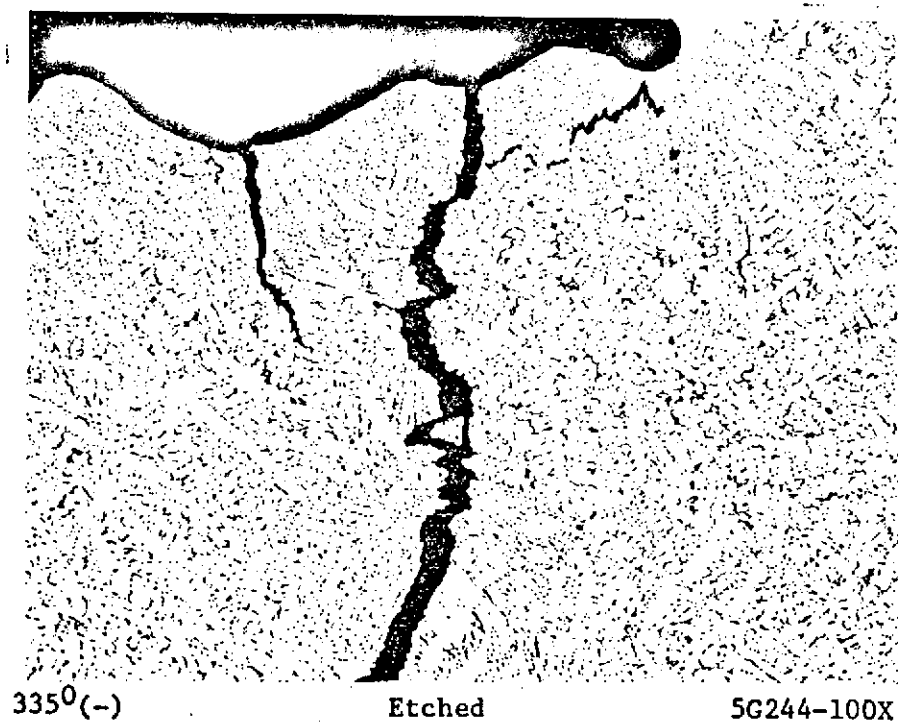
a. Crack near left edge in Figure A-19

b. Main crack near center in Figure A-19

FIGURE A-20. CRACKS IN DWELL REGION- H-1

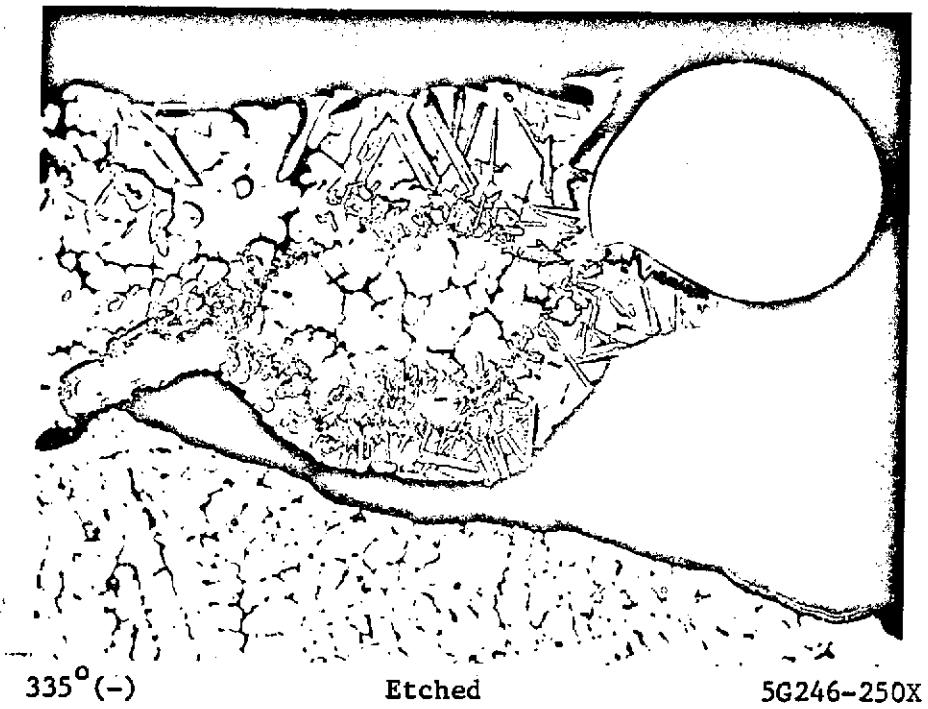
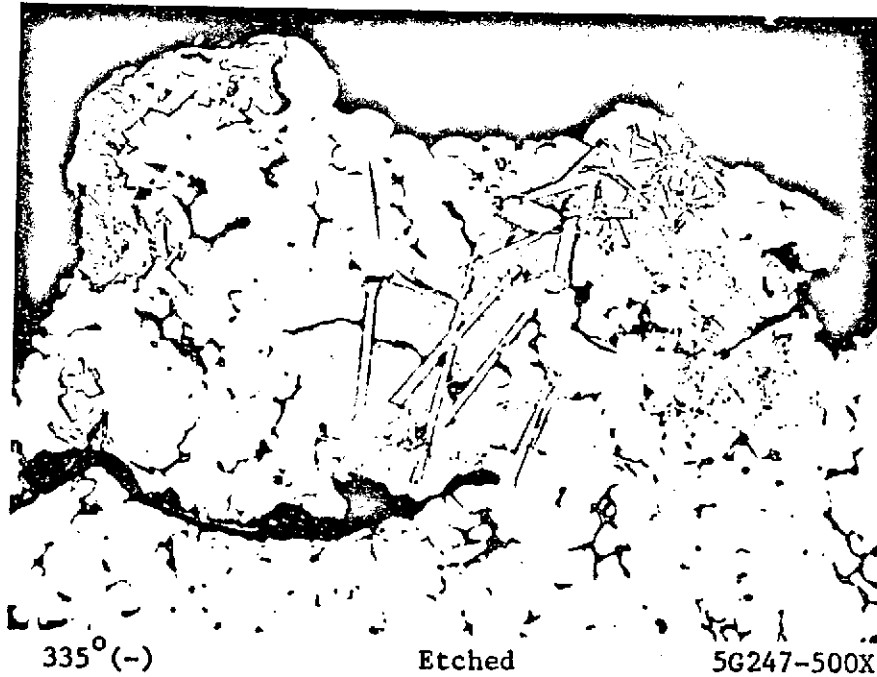
FIGURE A-21. MOLYBDENUM TRACES ON SURFACES OF
DWELL REGION- H-1

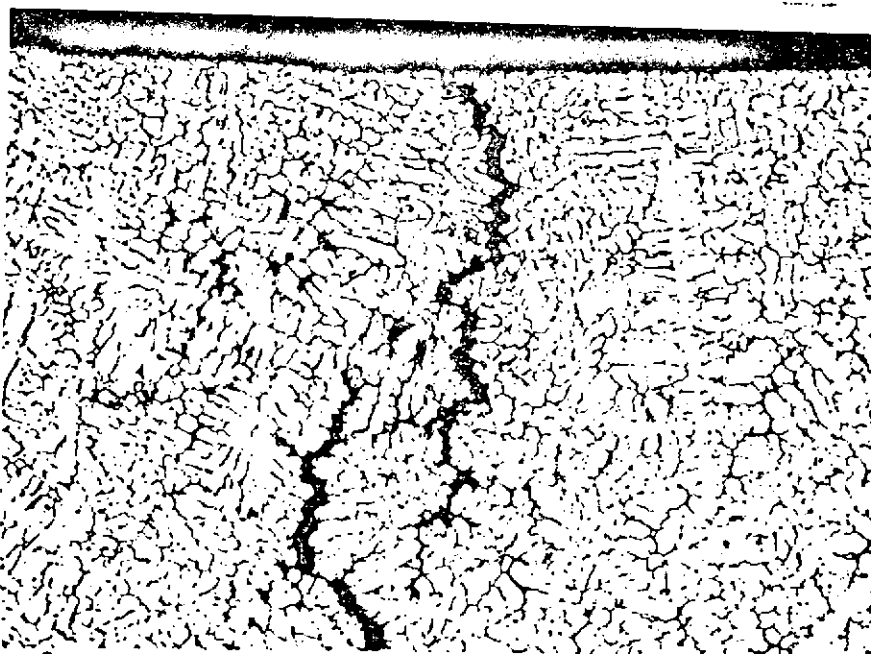
FIGURE A-30. SECTION THROUGH CRACK
IN DWELL REGION - S/N-124
